# Manhole Inspection Summary

Manhole # S49U1\_001MH

Insp Date: **6/4/08 10:29 AM**

**Location** Address: **3100 Frankfurst Ave.**

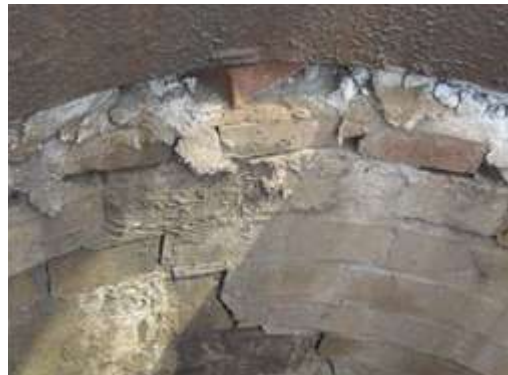
Defect 1

Condition: ☐ Sound ☐ Cracked ☐ Root Intrusion ☐ Loose Brick ☒ **Deteriorated**

Deteriorated Frame-Chimney joint.

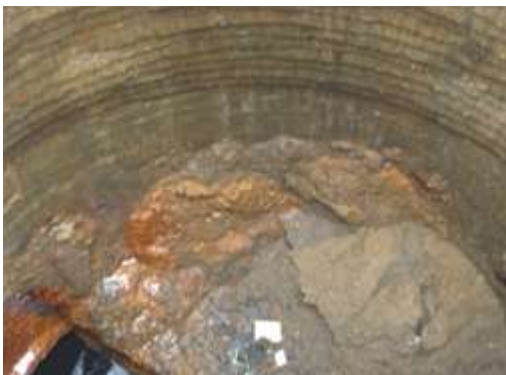
Defect 2

Condition: ☐ Sound ☐ Cracked ☐ Root Intrusion ☐ Loose Brick ☒ **Deteriorated**

Infiltration: ☐ None ☐ Joint ☒ **Cracks** ☐ Mortar ☐ Roots ☒ **Wall**

Condition: ☐ Sound ☐ Cracked ☐ Root Intrusion ☐ Deteriorated ☐ Leaks ☒ **Debris**

Deteriorated barrel and debris on bench.

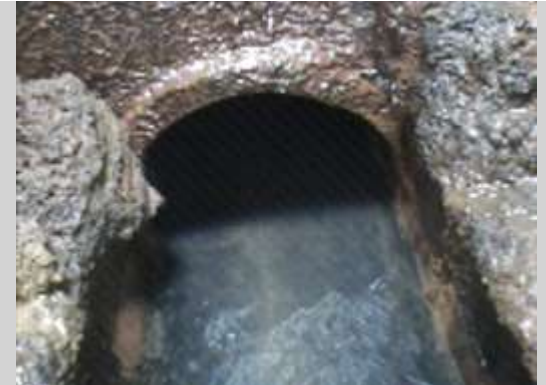
12 O'Clock Outflow

12 in. Circular Gravity Sewer  
Pipe Out @ 12 O'Clock

Pipe Height: **12** (in.) Rod and Bar (Angled)  
Pipe Material: **Clay** ☐ Pipe Lined  
Invert Depth: **12.38** (ft.) Flow Characteristics: **Fast**  
Deposits: ☒ None ☐ Mud ☐ Sludge ☐ Debris ☐ Grease  
Silt Depth: (in.) Deposits Extent:  
Infiltration: **None** Pipe Seal Cond: **Sound**

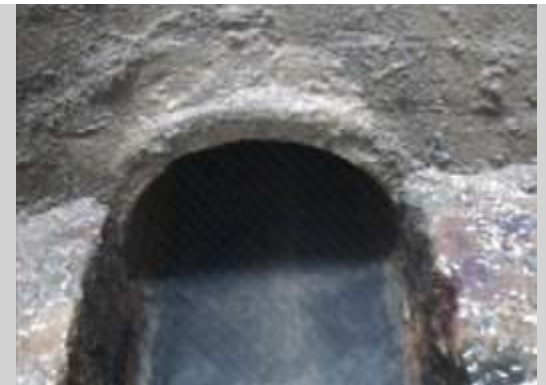
6 O'Clock Inflow

12 in. Circular Gravity Sewer  
Pipe In @ 6 O'Clock

Pipe Height: **12** (in.) Rod and Bar (Angled)  
Pipe Material: **Clay** ☐ Pipe Lined  
Invert Depth: **12.28** (ft.) Flow Characteristics: **Fast**  
Deposits: ☒ None ☐ Mud ☐ Sludge ☐ Debris ☐ Grease  
Silt Depth: (in.) Deposits Extent:  
Infiltration: **None** Pipe Seal Cond: **Sound**
